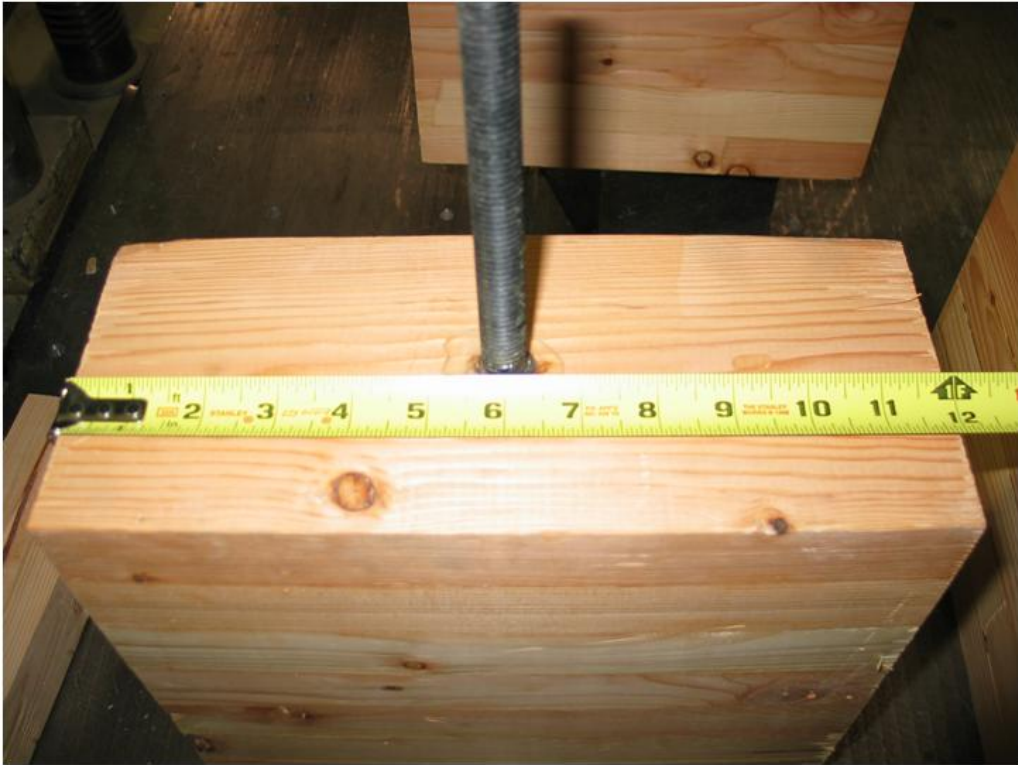
Figure 1: Glulam test specimens with threaded rod exposed.

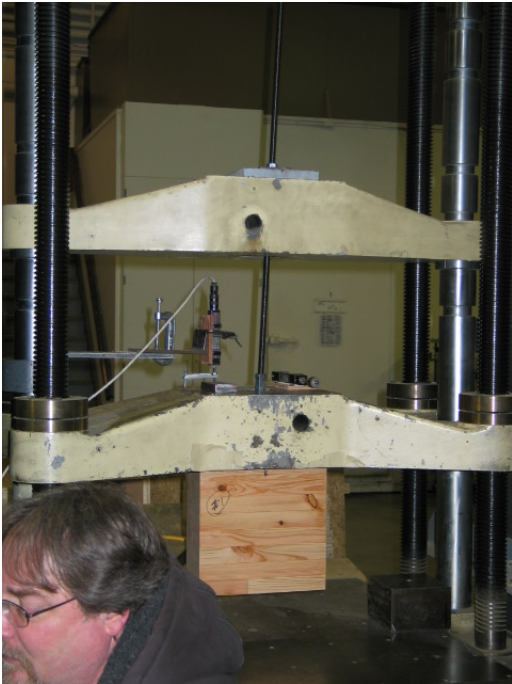
Figure 2: Overall test setup, threaded rod extends through square hole in bottom load head.

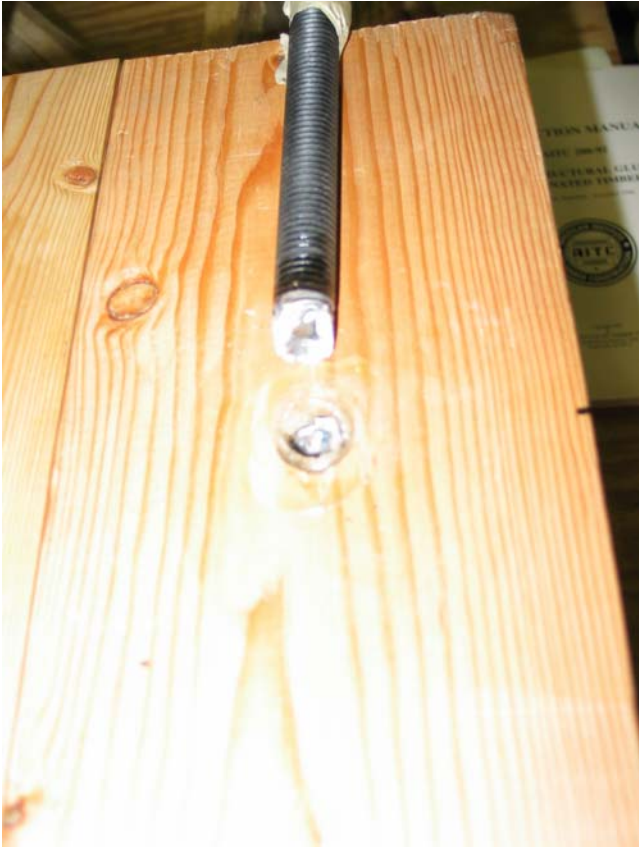
Specimen	Failure Time (mm:ss)	Peak Withdrawal Load (lbf)	Moisture Content (%)	Specific Gravity ⁽¹⁾	Failure Mode and Comments
1	11:10	15,091	11.2	0.48	Weld failure between rebar and threaded rod (Figure 3)
2	8:46	15,746	11.7	0.47	Weld failure between rebar and threaded rod (Figure 3)
3	10:15	16,620	12.0	0.49	Coupler nut failure in net facture (Figure 4). This specimen was retested to failure with a second coupler nut, resulting in rebar withdrawal failure at a lower load of 16,043 lbf.

Figure 3: Weld failure between rebar and threaded rod.

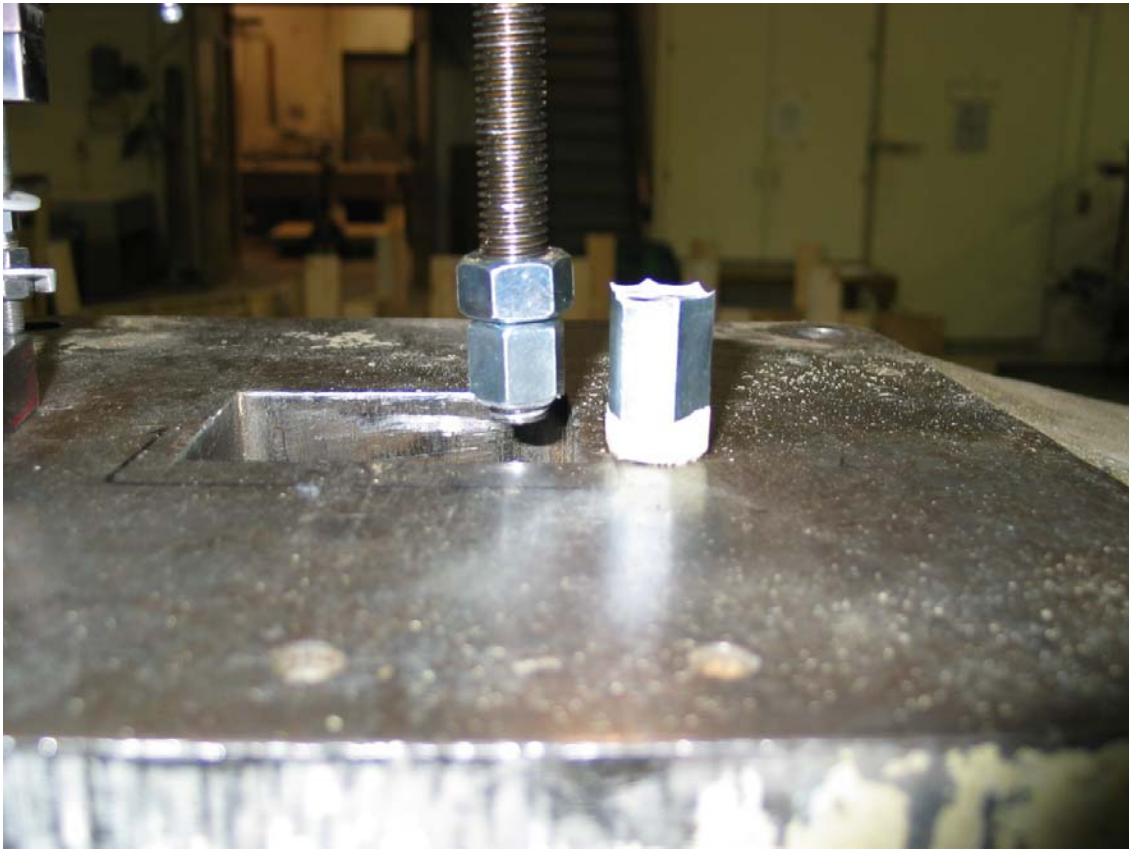
Figure 4: Couple nut fracture.
